UNITED STATES ARMY HELICOPTER ACCIDENTS INVOLVING FIRE

By
Emil Spezia

Report No. 1-64

UNITED STATES ARMY BOARD FOR
AVIATION ACCIDENT RESEARCH
Fort Rucker, Alabama

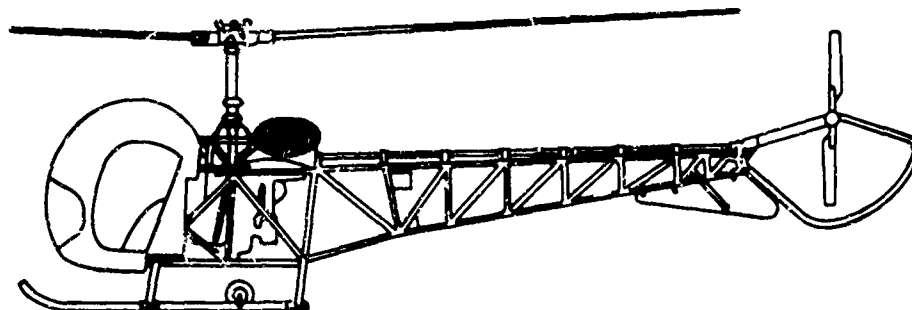
FIGURE 1

OH-13 models D and E single fuel cell

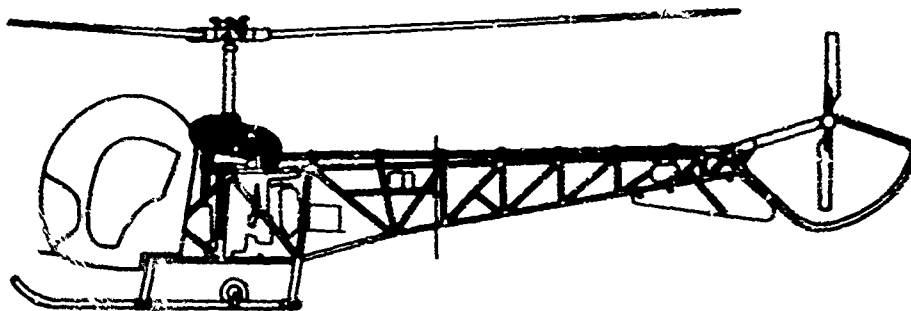
FIGURE 2

OH-13 models G and H twin fuel cells

The susceptibility of fuel cells to rupture when located in a position similar to those of the OH-13G and H series is reflected in this statement: "The main rotor blades struck the ground six times and stopped revolving. The impact of the main rotor blades caused the aircraft to roll to its left and strike the ground with the left gasoline tank, then bounce and come to rest on its right side. As it came to rest, the fuel tank and lines were ruptured allowing fuel to contact the hot engine. . . "7

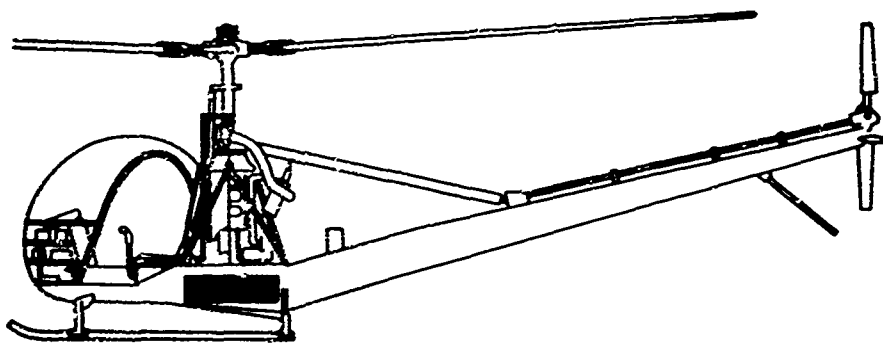
FIGURE 3

OH-23 single bladder-type fuel cell

type fuel cells, shielded by the cockpit floor and outer skin, is near ideal (Figure 3). The type of flying done by the OH-23 and the type of accidents it is involved in indicates that the OH-23 fuel cell installation has proven to be highly crash resistant (Table 5).

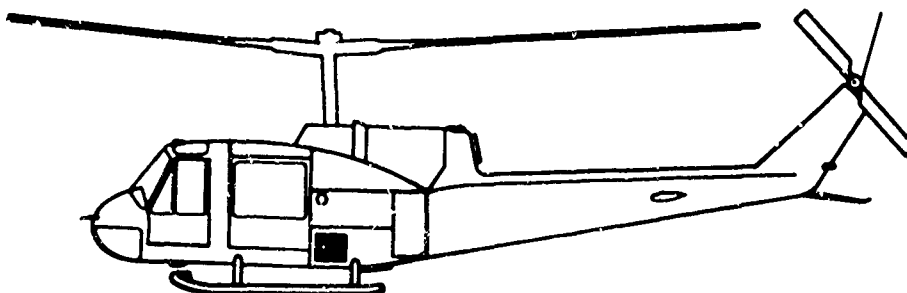
FIGURE 4

The UH-1 bladder-type cells located aft and outboard of the cockpit with most of the cells above the cockpit floor provide added protection (Figure 4). The lower portion of the cells are extra strength self-sealing, while a layer of energy-absorbing honeycomb surrounds the lower portion of cells adjacent to the skin. As a result, statements taken from a UH-1D, FY 1964, accident report read: "Sharp object (tree trunk) penetrated the fuselage bottom under the left forward fuel cell and crushed the protective honeycomb layer without affecting fuel cell integrity."²

UH-1 bladder-type fuel cells aft and outboard of the cockpit

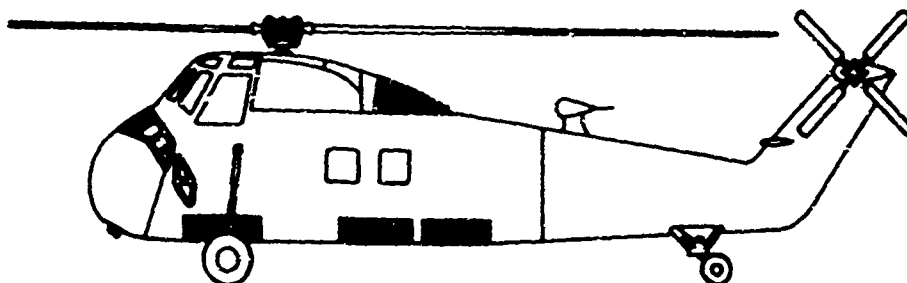
FIGURE 5

CH-34 with three fuel cells in the belly of the helicopter

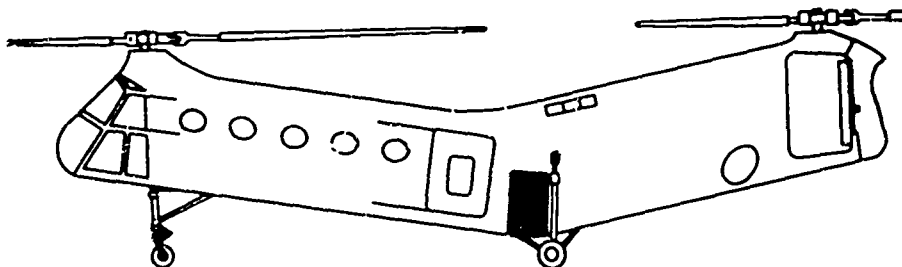
FIGURE 6

Fire erupting due to the landing gear penetrating the fuselage and puncturing the fuel cells is not an unusual experience for the CH-21 and UH-19. Figures 6 and 7, respectively, show the relative location of the fuel cells and landing gear in these aircraft.

CH-21 fuel cell location in relation to landing gear

The fire hazard in this type of installation is evident in the following statement: "The aircraft (CH-21) contacted the ground with an excessive rate of descent resulting in a hard touchdown which caused both main gear struts to detach at the upper end and the fuel cells to rupture. The aircraft immediately burst into flames."⁸ Fire in the two CH-21 roll-over type accidents listed in Table 5 are also the result of gear punctured fuel cells.

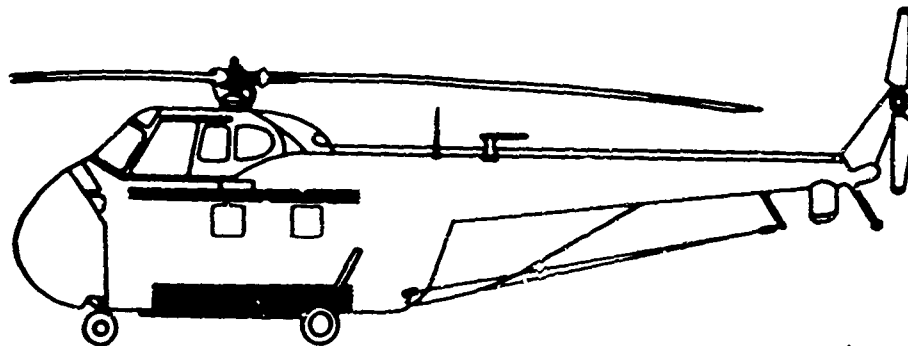
FIGURE 7

UH-19 fuel cell location in relation to landing gear

The UH-19 and CH-34 experience, as the following statement from a UH-19 report illustrates, are quite similar. In addition, the fire origin is pinpointed—a fact seldom determined. "The left main gear was forced upward by the impact and punctured the left side of the aft tank. Subsequent pitching motion caused fuel from the punctured tank to splash forward making contact with either the engine exhaust or the engine itself, causing the fire."⁹
